AEFA Project No. 88-06

# ARTIFICIAL AND NATURAL ICING TESTS OF THE EH-60A QUICK FIX HELICOPTER

June 1988

Final Report

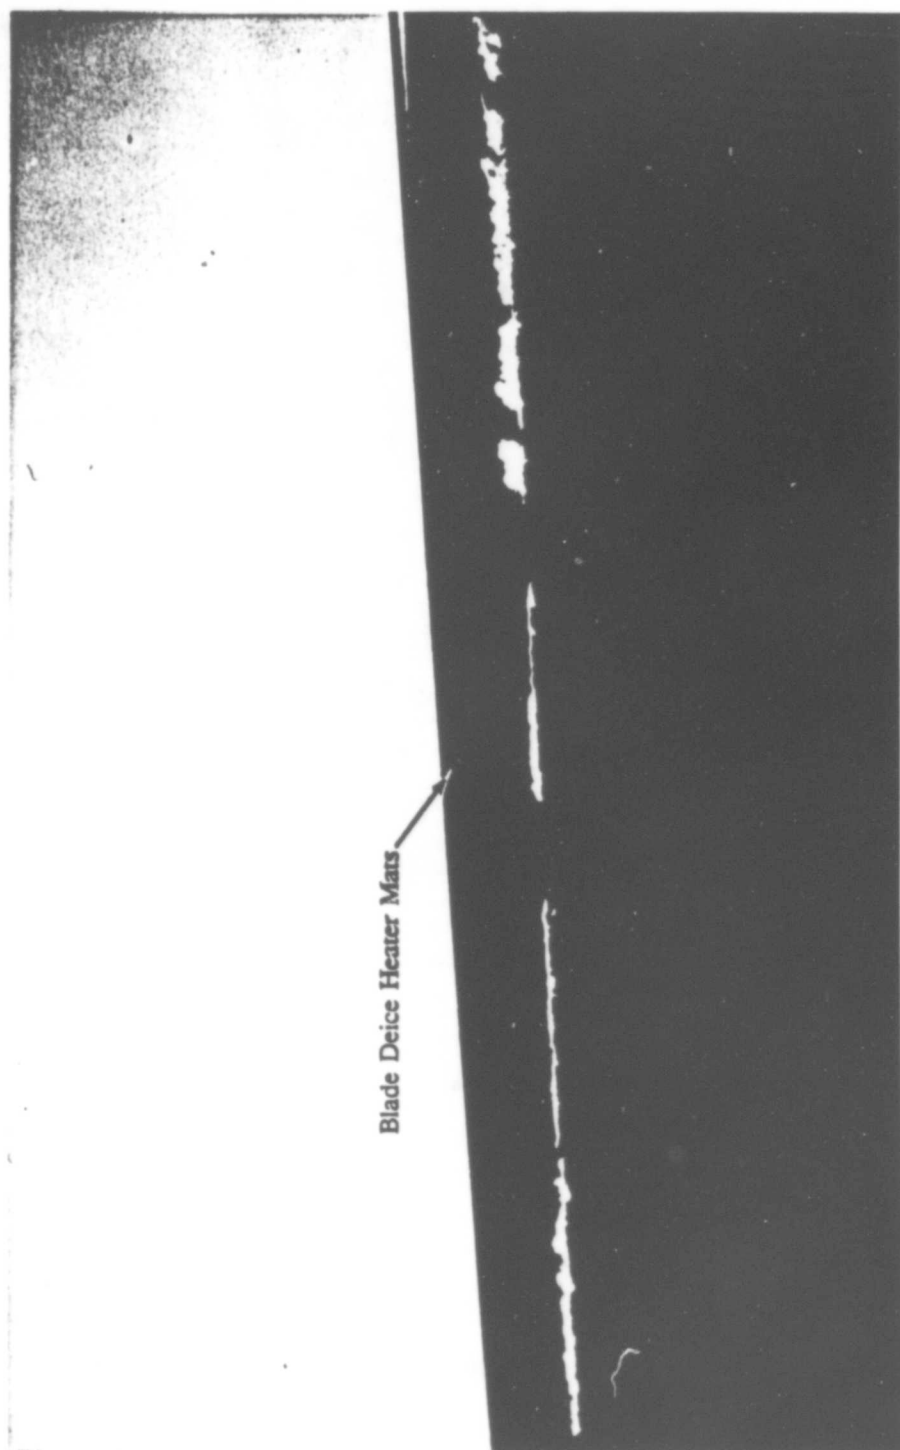
11. The ice accretion and operational characteristics of the main rotor were evaluated throughout these tests. During a natural icing flight at  $-13.0^\circ\text{C}$  and LWC of  $0.55 \text{ gm/m}^3$ , an increase of 27% indicated torque was observed. The cloud was entered with a 55% indicated torque and was flown collective fixed. After approximately fifteen minutes an indicated torque of 72% was attained. Following a blade deice cycle, the indicated torque dropped to 67% and began cycling between 68% to 72% correlating with the blade deice cycles. At twenty minutes the cloud was exited to visual meteorological conditions. One minute after exiting the cloud, the indicated torque returned to 58%. Post flight inspection revealed one inch fingers of ice protruding forward from the trailing edge of

Figure H-1. Main Rotor Blade Ice Accumulation  
Natural Icing - .55 gm/m<sup>3</sup> LWC, -13°C OAT, 21 min

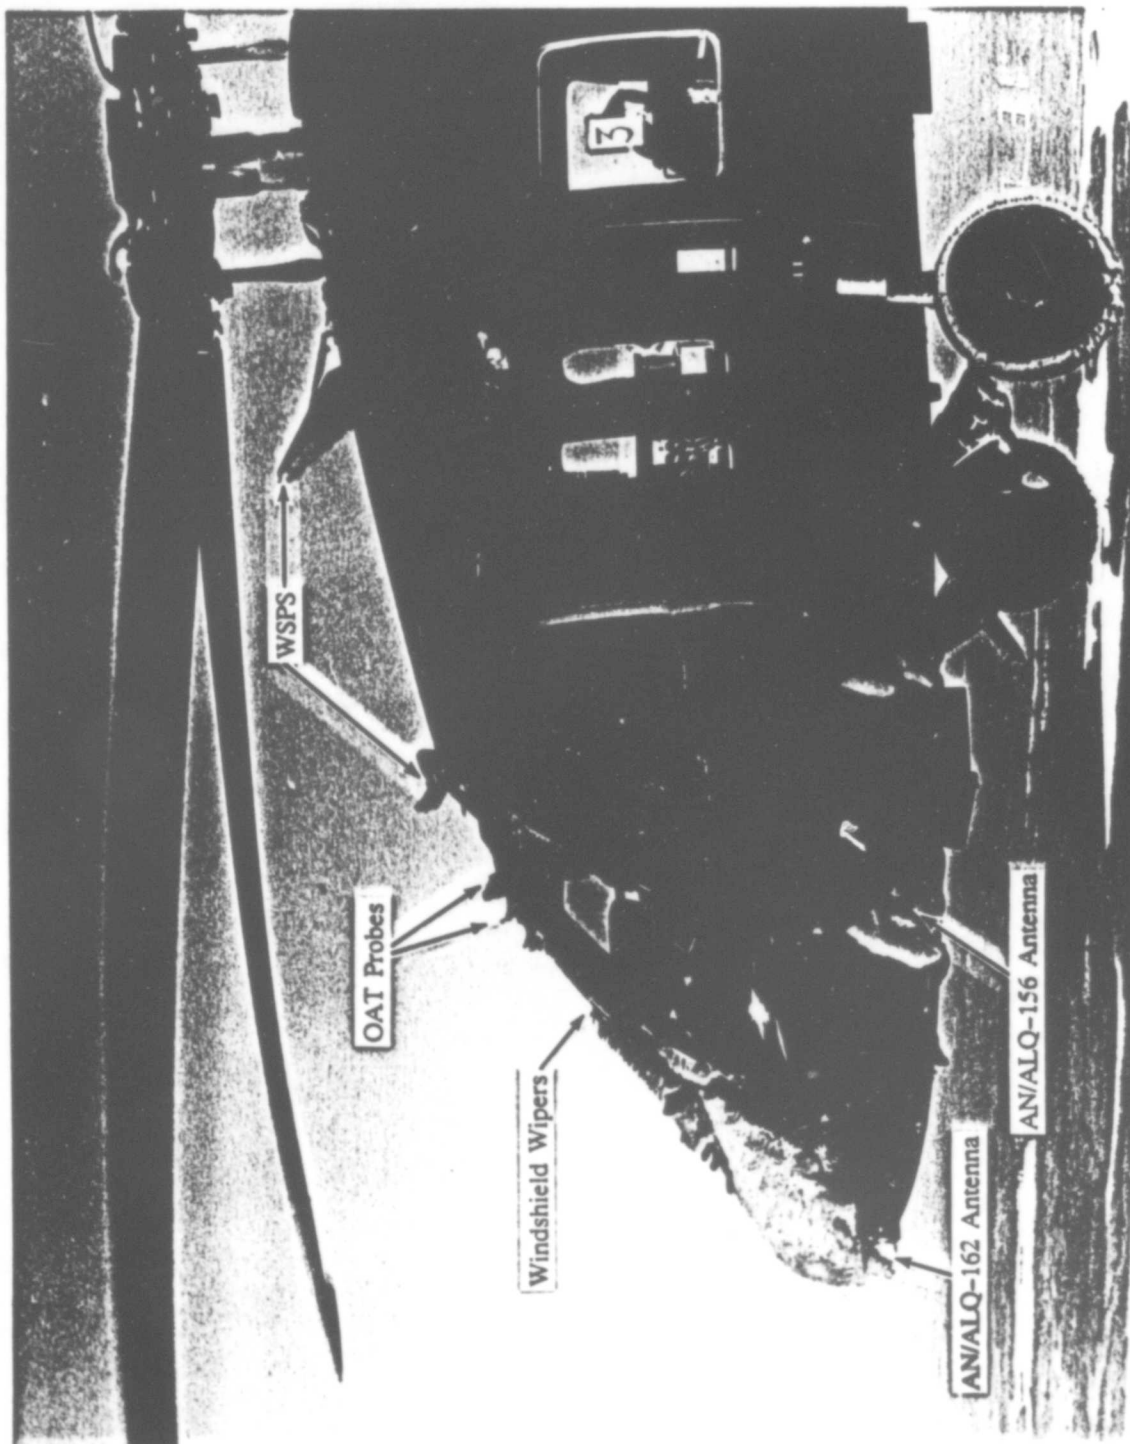
Figure H-2. Airframe Ice Accumulation  
Artificial Icing - .95 gm/m<sup>3</sup> LWC, -5.1°C OAT, 57 min

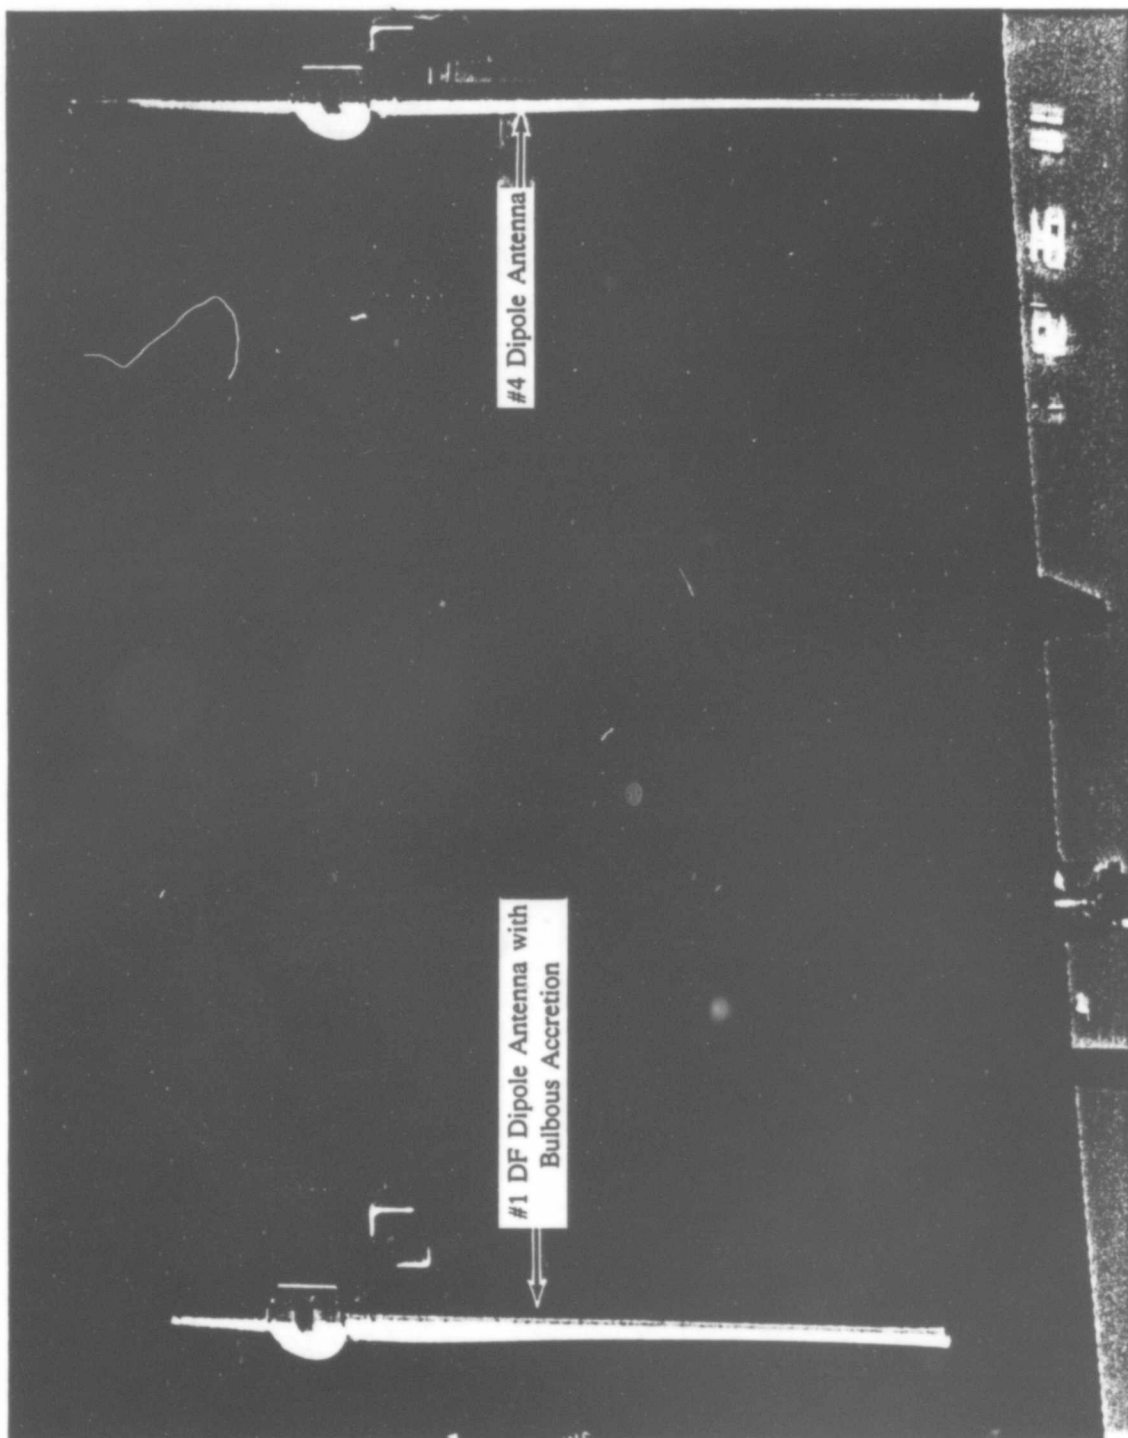
13. The ice accretion characteristics of the DF dipole antennas were evaluated throughout these tests. Ice accumulation varied with antenna location (fig. H-3). The number three antenna accreted less ice than the other three throughout the tests. The upper elements of the DF antennas accreted ice from the phenolic blocks upward to approximately 20% of the element length and did not shed during flight. The lower elements accreted ice the full length of the element with a bulbous accretion just below the phenolic block (fig. H-3). Ice accumulation caused the DF antennas to oscillate. During oscillation, the upper 50 to 60% of the lower elements would self shed leaving the remaining accumulated ice near the tip (fig. H-4). Following the self shed, the amplitude of the oscillation would increase. Post flight inspection revealed loose DF element retaining screws. Flight in artificial icing conditions resulted in a high frequency vibration of the lower element of the number two DF antenna with tip amplitudes of  $\pm 4$  inches. At forty four minutes into an artificial icing immersion at  $-15.0^{\circ}\text{C}$  and LWC of  $0.52 \text{ gm/m}^3$ , the upper left screw on the number two lower DF antenna mount sheared just below the screw head (fig. H-5). At 21 minutes into a natural icing immersion at  $-9.3^{\circ}\text{C}$  and LWC of  $0.20 \text{ gm/m}^3$ , the upper right screw on the number two lower DF antenna mount sheared approximately 0.2 inch below the screw head (fig. H-6). Post flight measurement recorded 1.25 inches of ice accumulation on portions of the DF antenna elements (fig. H-7). No damage to the DF antennas or their mounts was noted. At 30 minutes into a natural icing immersion at  $-13.0^{\circ}\text{C}$  and LWC of  $0.55 \text{ gm/m}^3$ , a  $\pm 4$  inch tip amplitude vibration of the lower element of the number two DF antenna element was observed and abruptly stopped with a simultaneous shed of ice from the element. Post flight inspection of the DF antennas revealed a cracked phenolic support block of the front right DF antenna (#2) (figs. H-8 and H-9). The Test Incident Reports (TIR) submitted by AEFA on these incidents are included in appendix G. The effect of ice accumulation on the proper function of the DF system was not tested. The excessive DF dipole antenna element oscillation induced by ice accumulation resulting in damage to

Figure H-3. Dipole Antenna Ice Accumulation  
Artificial Icing - .99 gm/m<sup>3</sup> LWC, -9.9°C OAT, 38 min

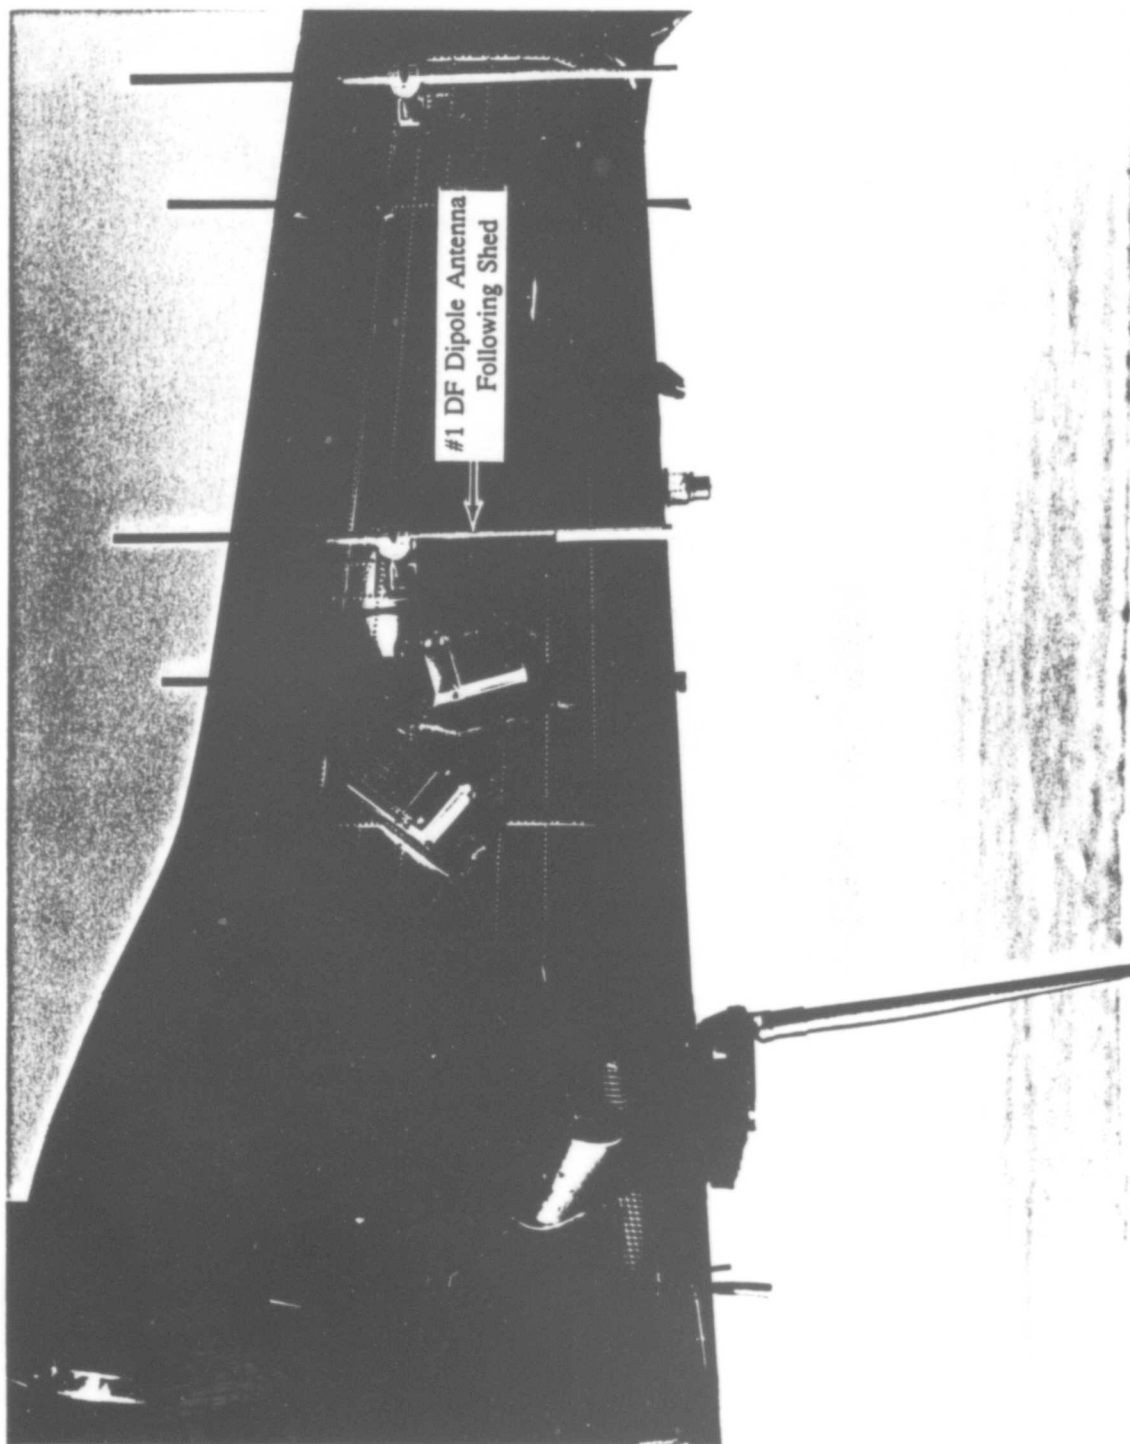
Figure H-4. Self Shed Pattern of Dipole Antennas  
Artificial Icing - .99 gm/m<sup>3</sup> LWC, -9.9°C OAT, 38 min

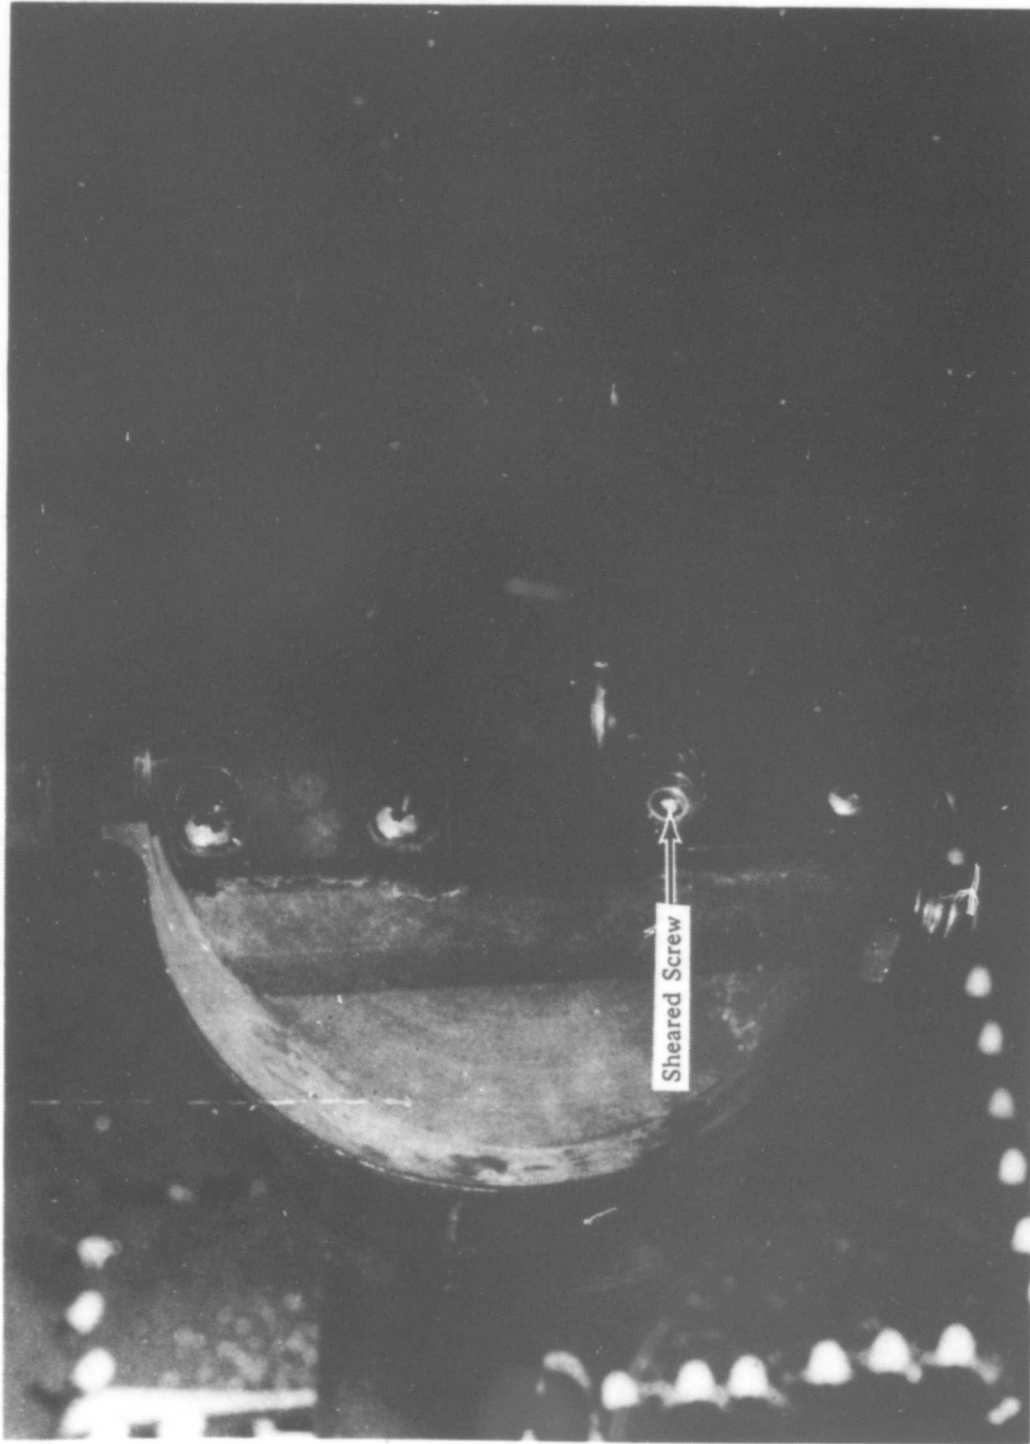
Figure H-5. Sheared Dipole Retaining Screw  
Artificial Icing - .52 gm/m<sup>3</sup> LWC, -15°C OAT, 44 min

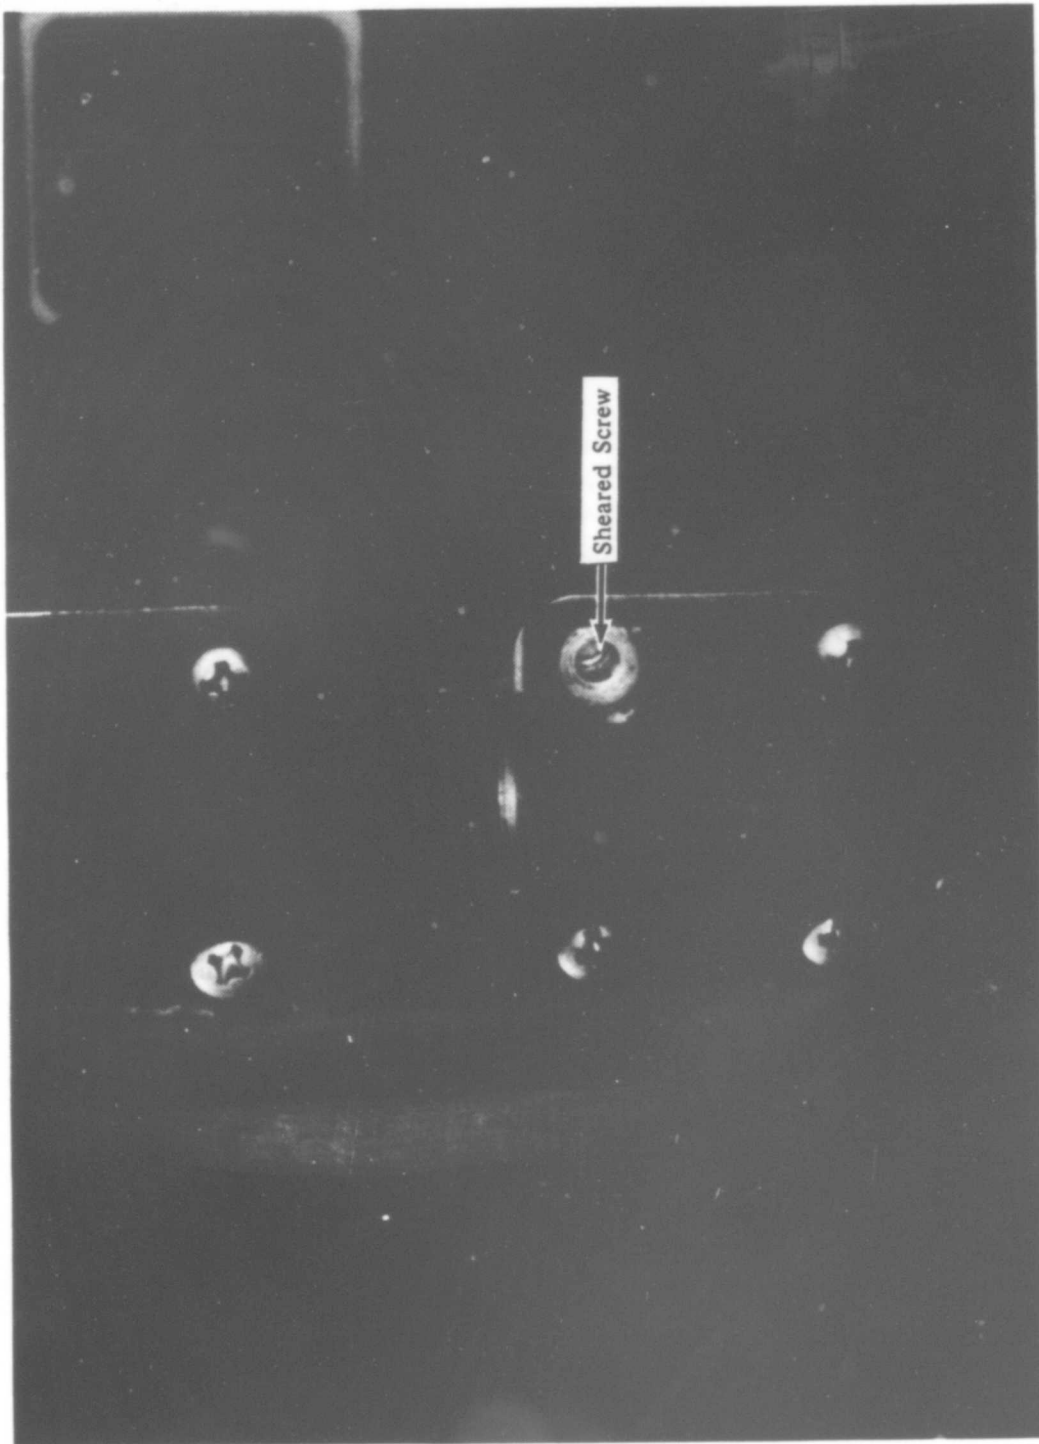
Figure H-6. Sheared Dipole Retaining Screw  
Natural Icing - .20 gm/m<sup>3</sup> LWC, -9.3°C OAT, 21 min

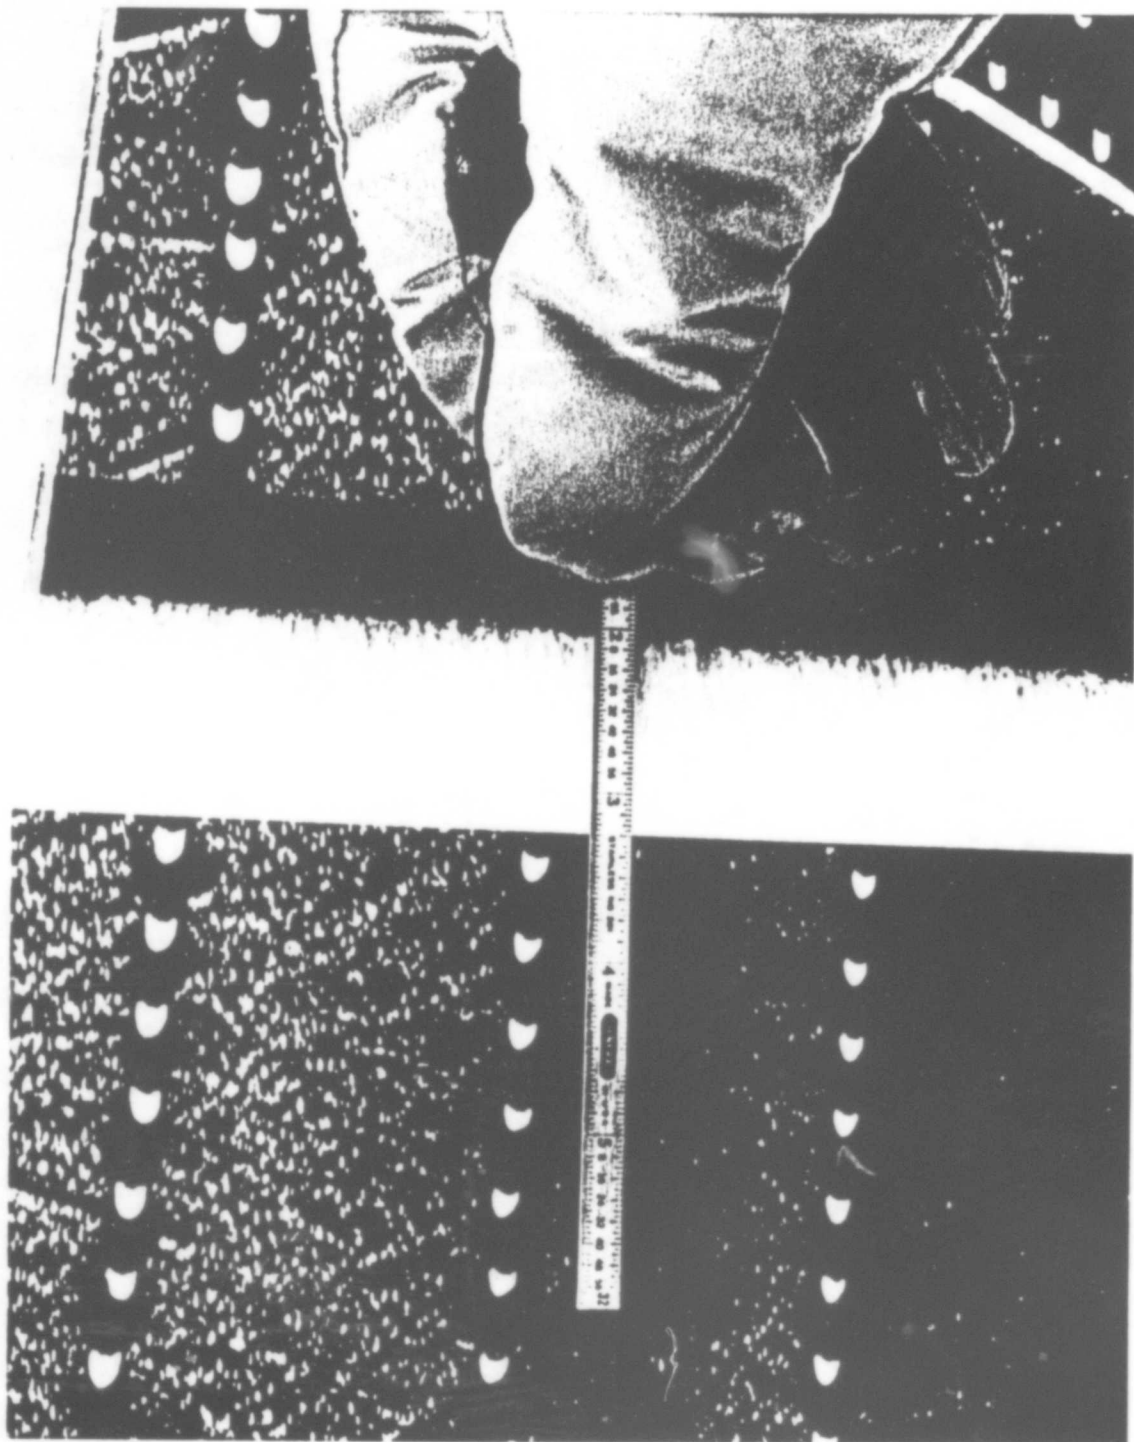
Figure H-7. Ice Accumulation on DF Antennas  
Artificial Icing - .52 gm/m<sup>3</sup> LWC, -15.0°C OAT, 60 min

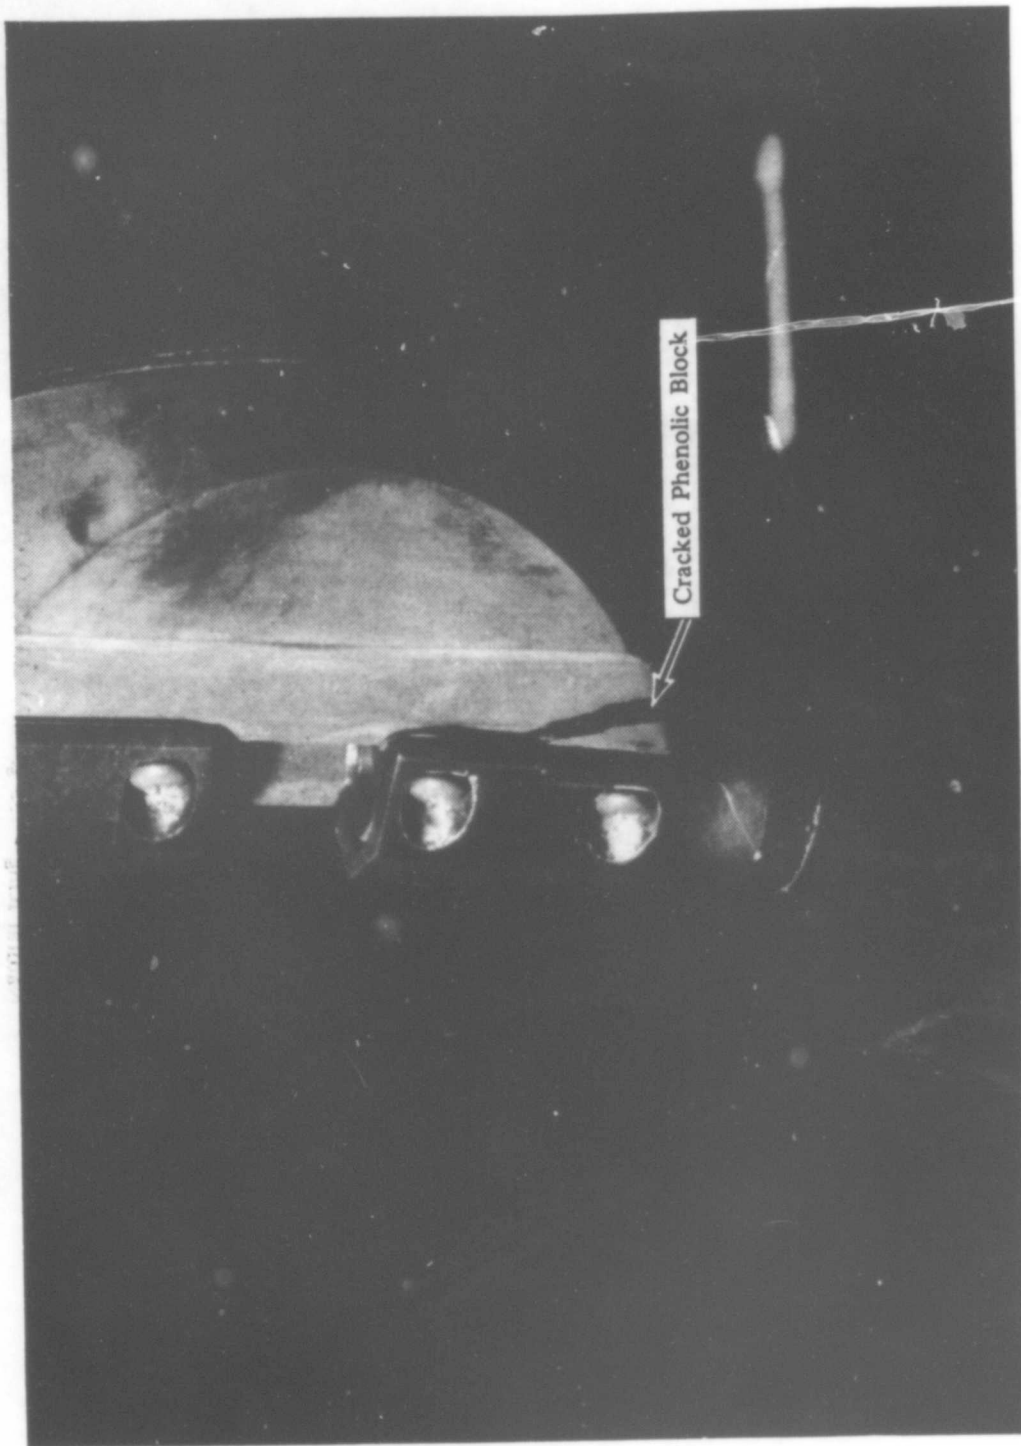
Figure H-8 #2 Dipole Antenna Cracked Phenolic Block  
Natural Icing - .55 gm/m<sup>3</sup> LWC, -13.0°C OAT, 21 min

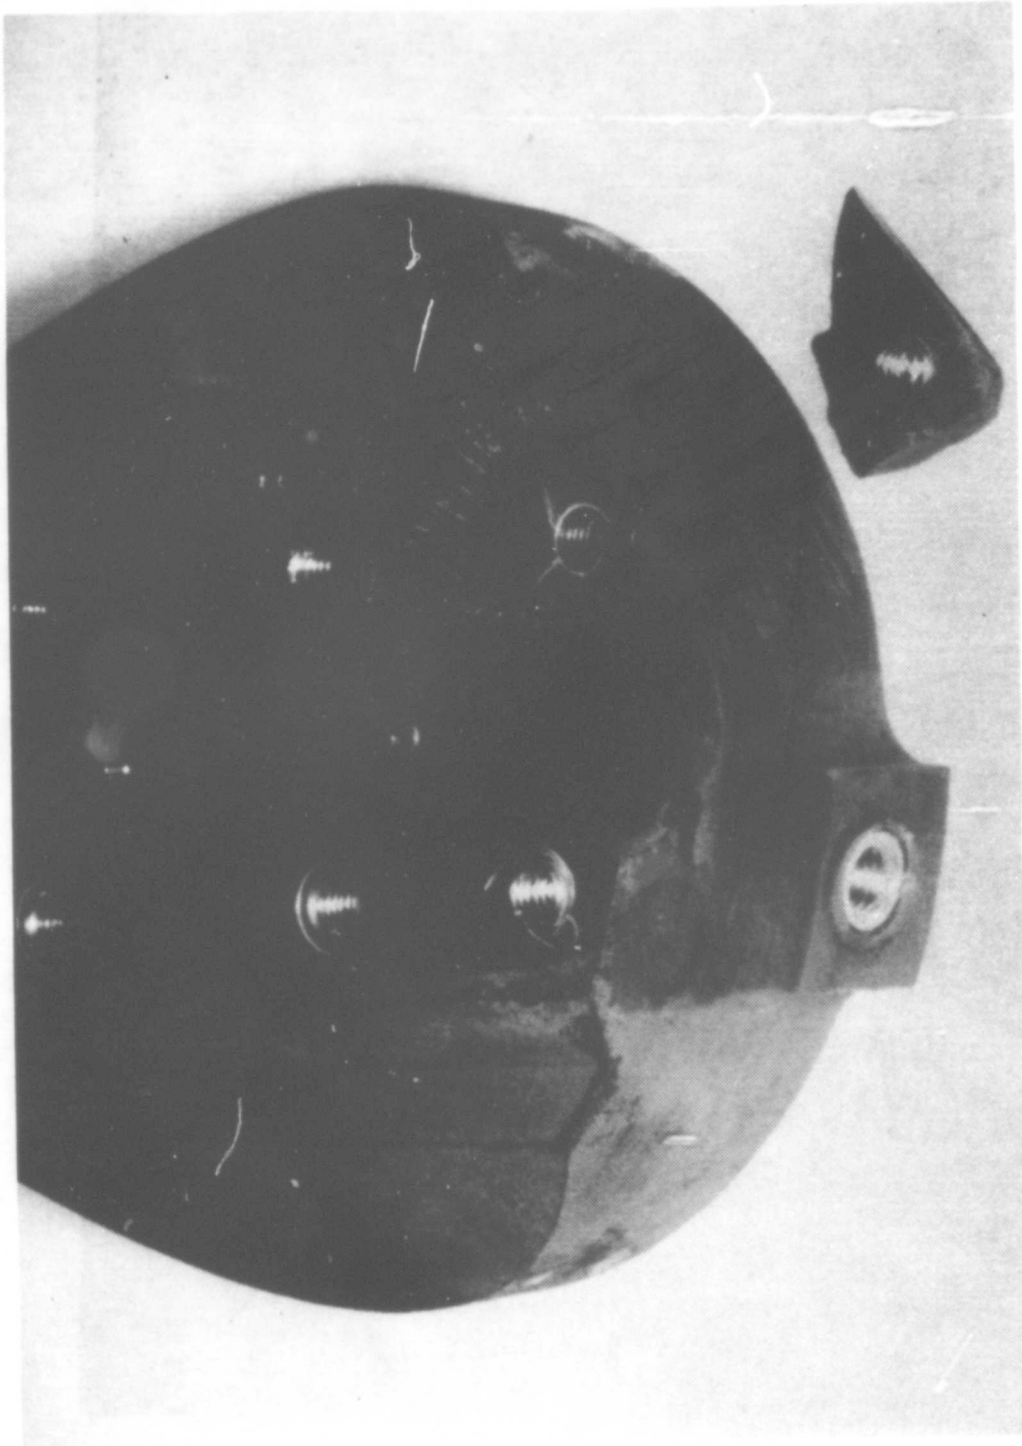
Figure H-9. Cracked Phenolic Block  
Natural Icing - .55 gm/m<sup>3</sup>, -13.0°C OAT, 21 min

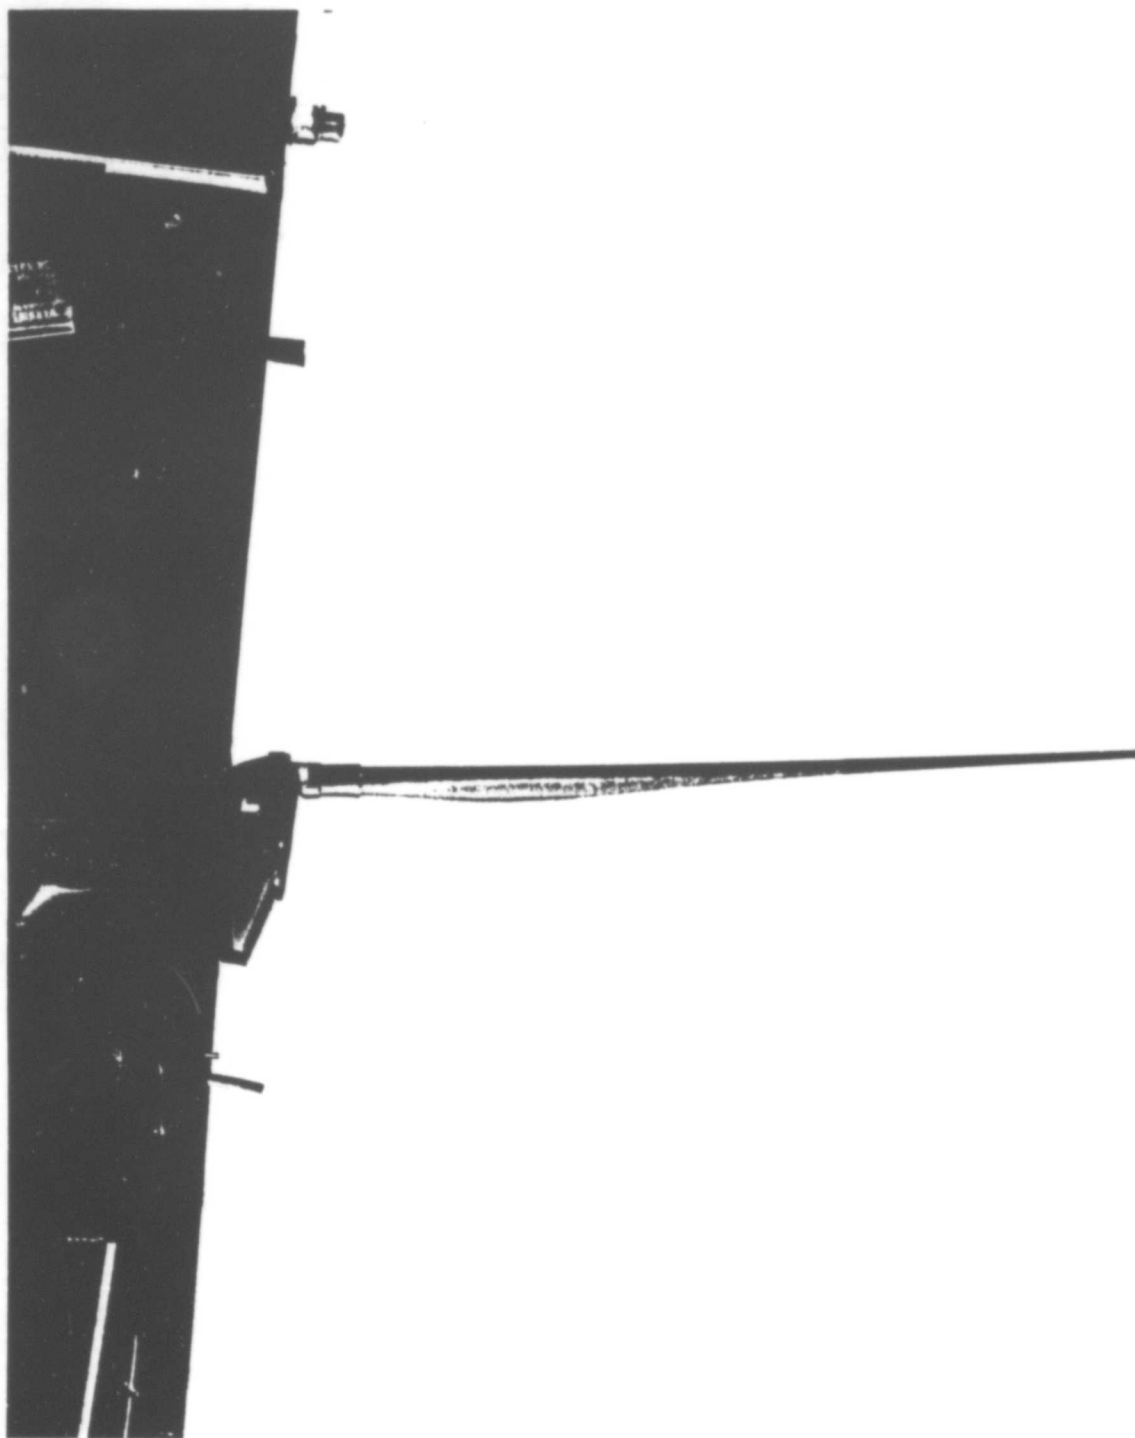
Figure H-10. ECM Antenna: Artificial Icing  
Artificial Icing - .95 gm/m<sup>3</sup> LWC, -5.1°C OAT, 57 min

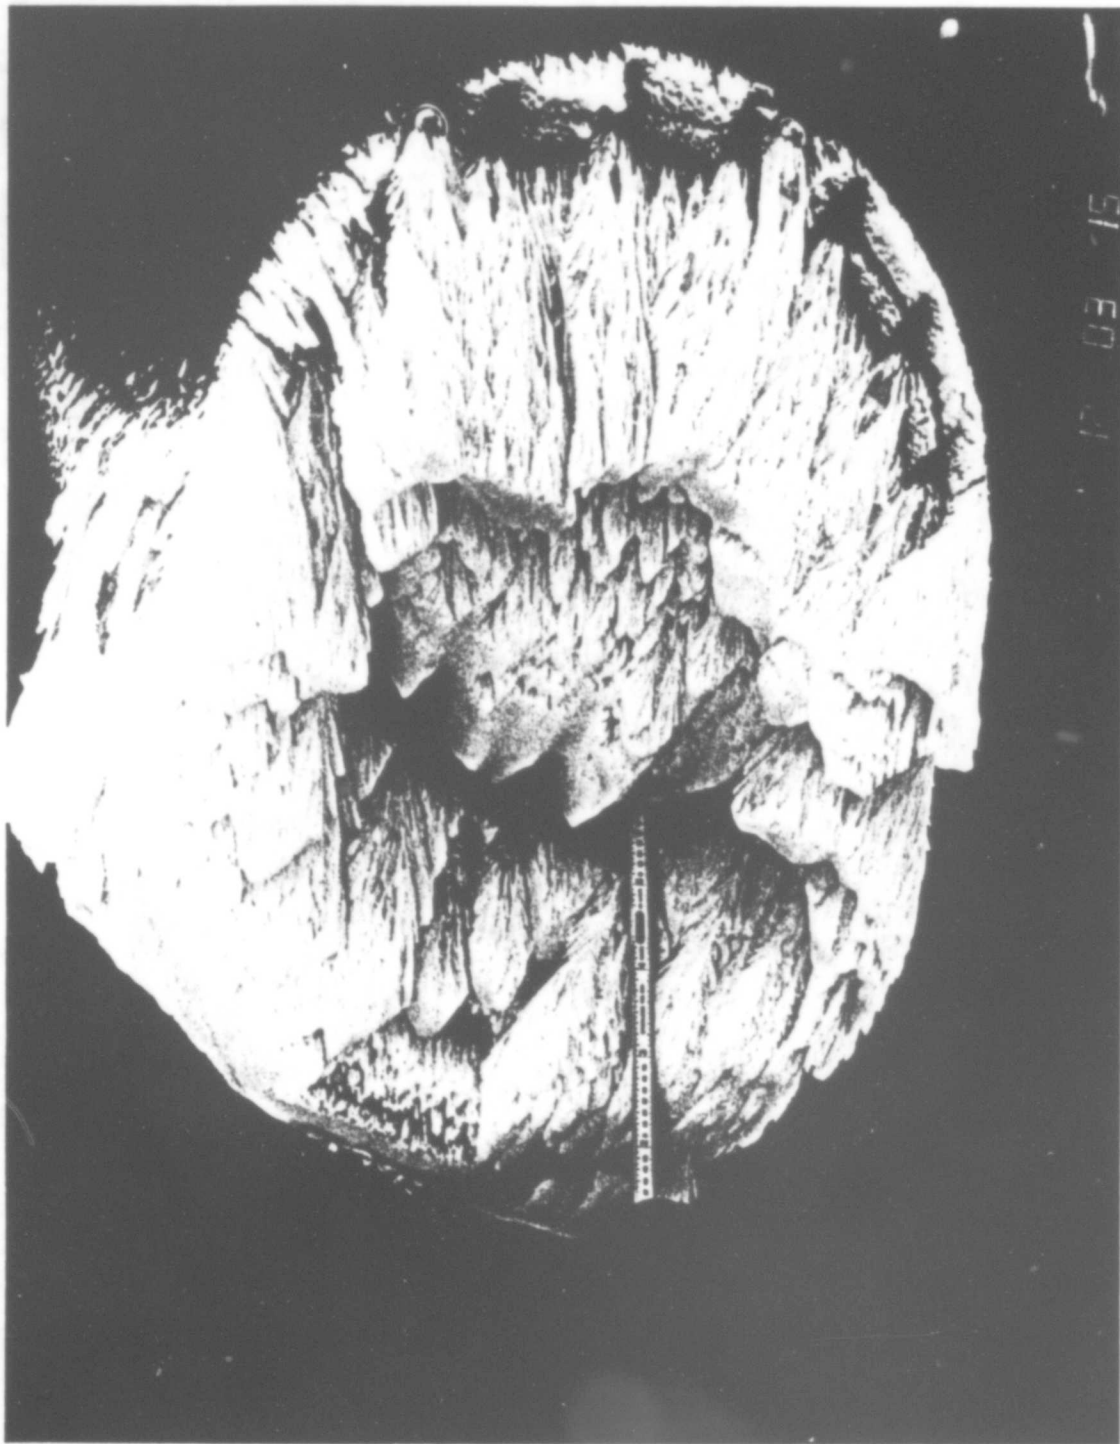
Figure H-11. AN/ALQ - 156 Antenna Accumulation  
Artificial Icing - .52 gm/m<sup>3</sup> LWC, -15.0 °C OAT, 60 min

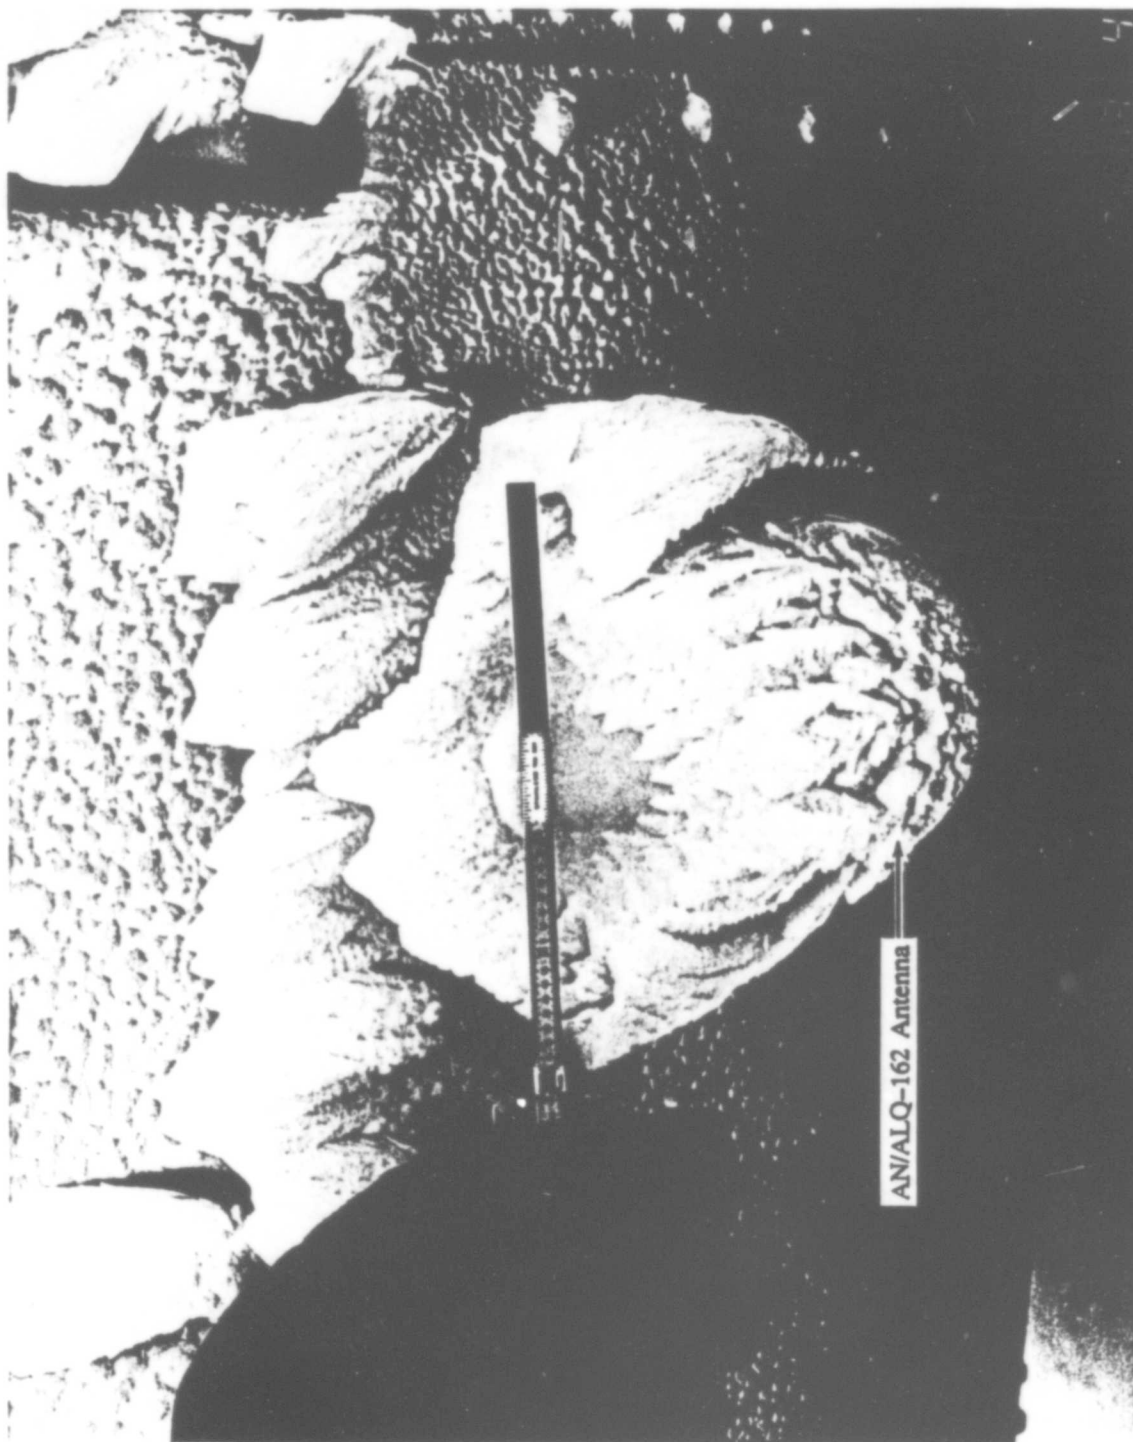
Figure H-12. AN/ALQ-162 Antenna Accumulation (Front View)  
Artificial Icing - .52 gm/m<sup>3</sup> LWC, -15.0°C OAT, 60 min

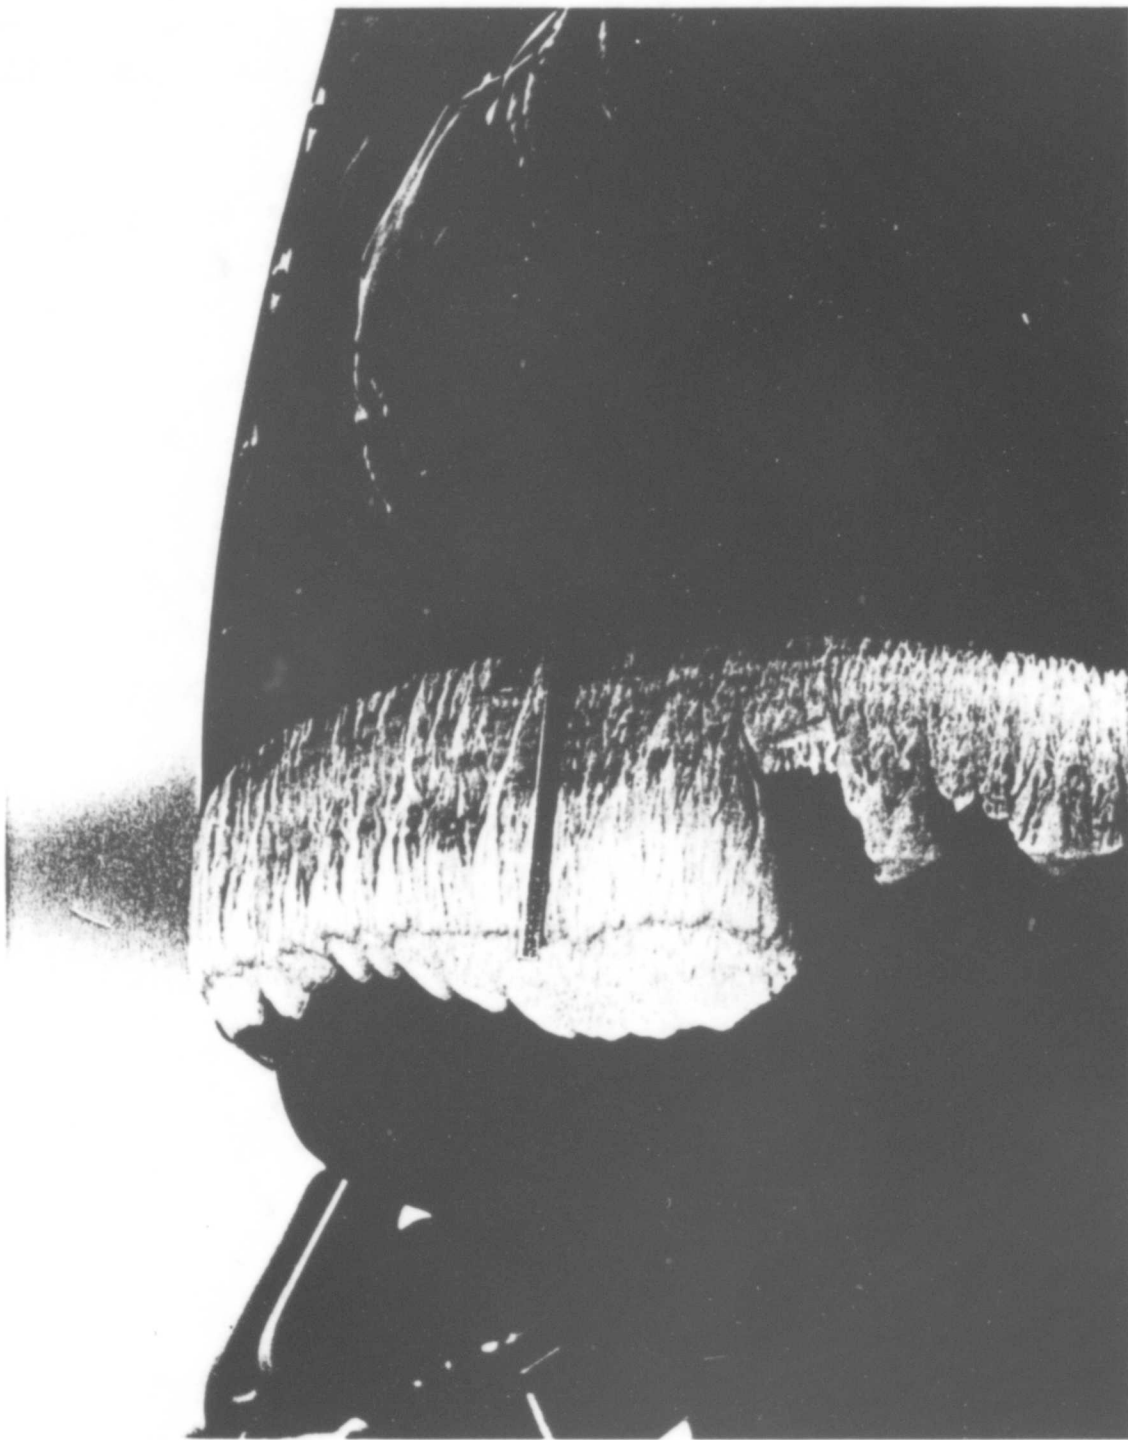
Figure H-14. HIRSS Engine Cooling Air Inlet Fairing  
Artificial Icing - .52 gm/m<sup>3</sup> LWC, -15.0°C OAT, 60 min

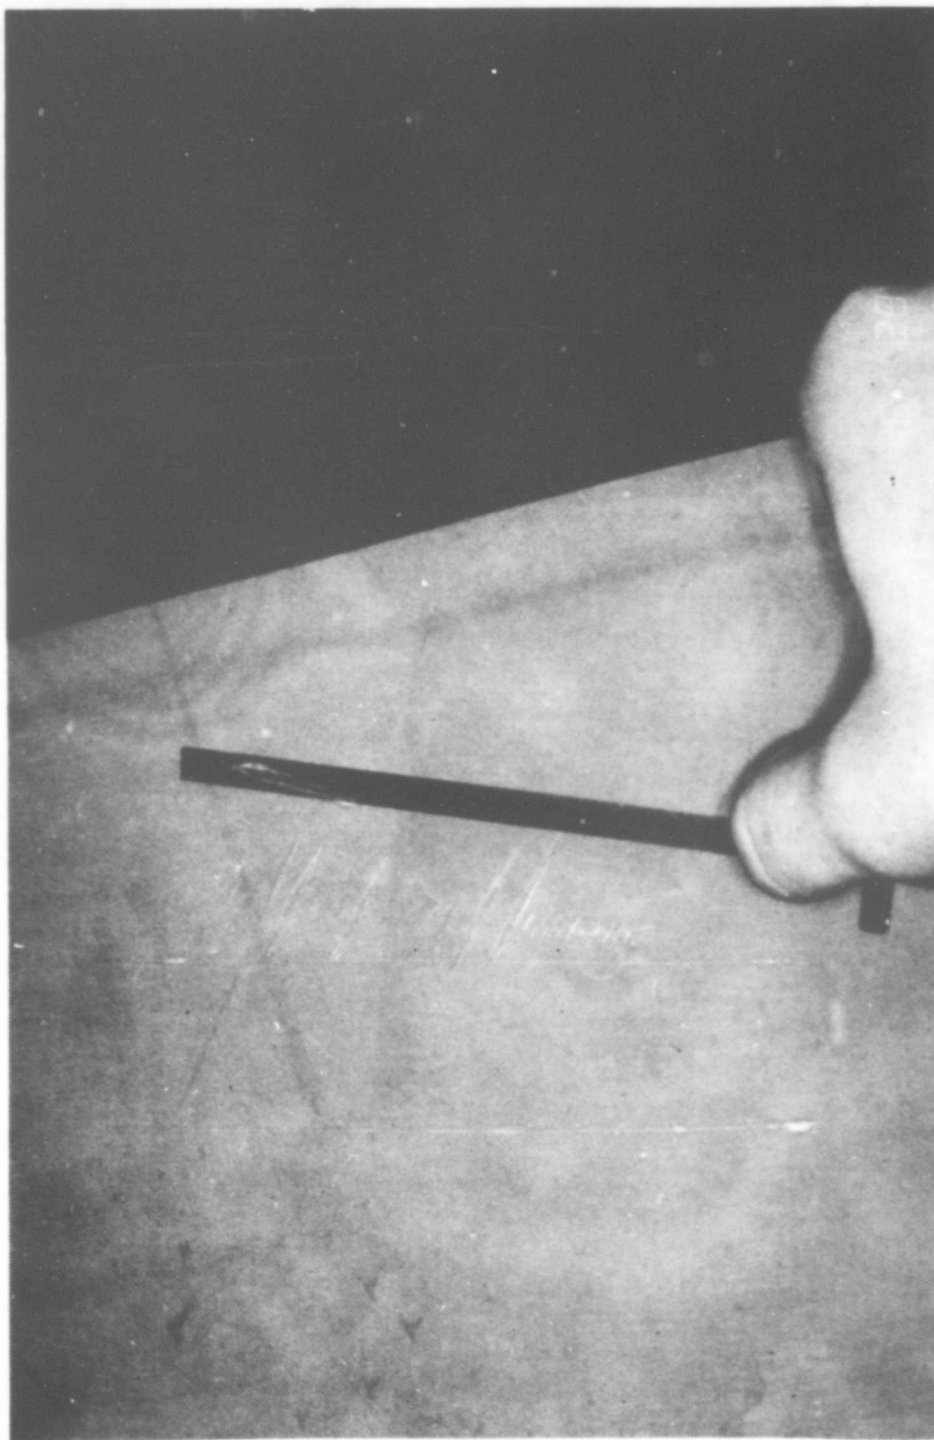
22. The tail rotor was damaged during an artificial icing flight of one hour duration at  $-19.6^{\circ}\text{C}$  and a LWC of  $0.45 \text{ gm/m}^3$ . Post flight inspection revealed a cut and dented area on the tail rotor blade which required replacement (fig. H-19). The damage caused no unusual vibration or change in aircraft handling characteristics. The TIR submitted by AEFA is presented in appendix G. Ice impact damage to the tail rotor paddle from uncontrolled shedding is a shortcoming.

Figure H-19. Damaged Tail Rotor Paddle  
Natural Icing - .45 gm/m<sup>3</sup> LWC, -19.6°C OAT, 60 min
